Advisory Visit River Sheaf (Leyburn Rd to Climbing Works)

Paul Gaskell (pgaskell@wildtrout.org)

05/04/2023

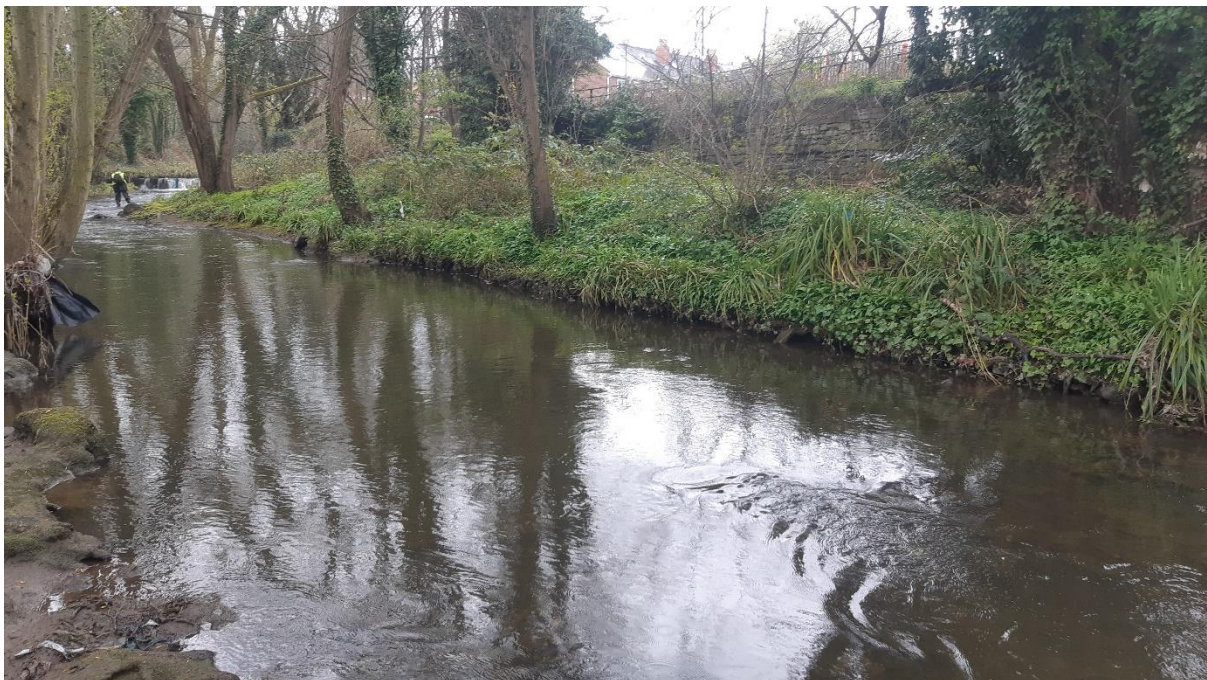
Figure 1: Facing upstream away from the downstream limit, the LB is shown on the opposite side of the channel from the camera and has a variety of native understory vegetation species as well as shrubs and mature trees.

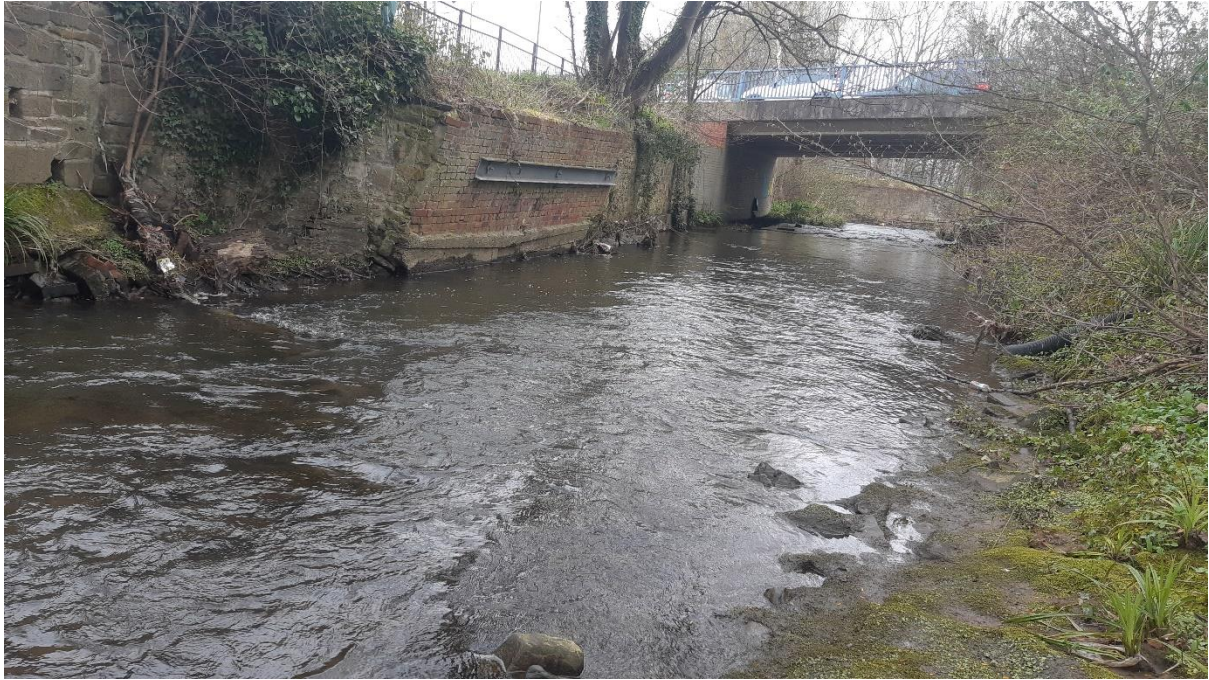
Figure 2: Facing downstream towards the downstream limit and the brick wall on the LB is clearly leaning over at a steep angle.

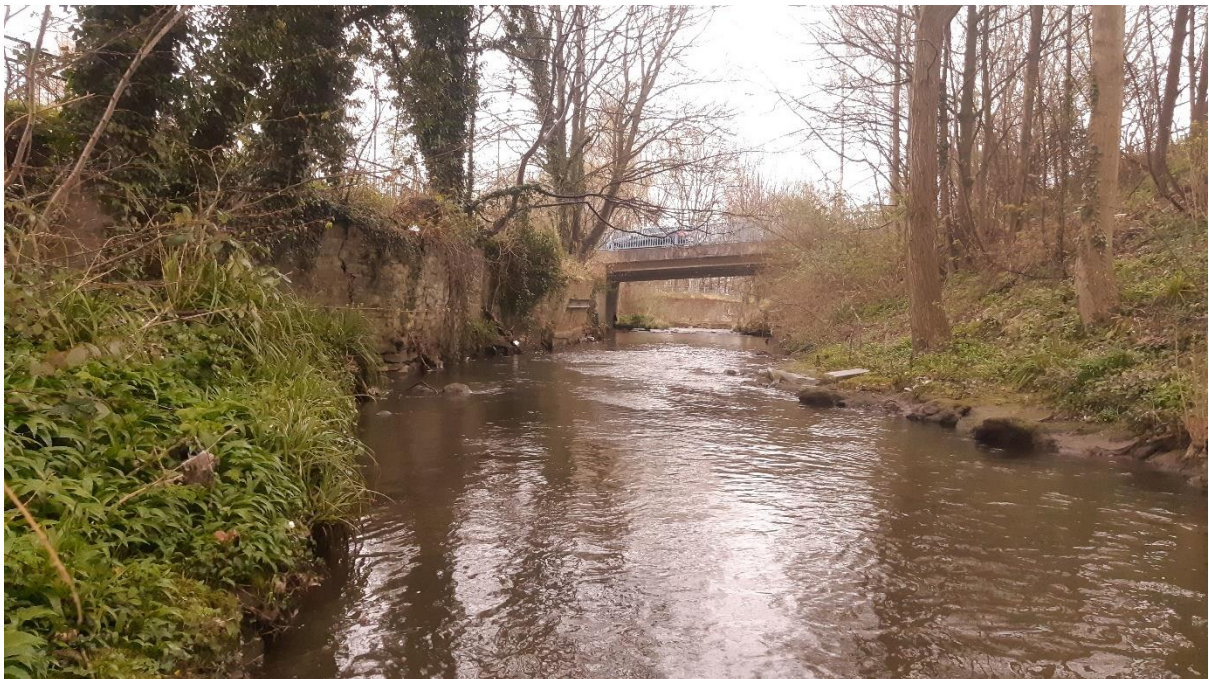
The undercut bank and trailing vegetation (foliage and roots) along the LB shown in Fig.3 is providing fish with refuge from predation. The surrounding tree canopy is a valuable source of shade and terrestrial subsidies to the watercourse. Leaf litter and invertebrate prey falling from the canopy into the water support particular groups of aquatic organisms. In turn, the emergence of aquatic insects from the water in their adult form provides essential prey for terrestrial predators, including (but not limited to) birds, bats and spiders.

Figure 3: Understory ground coverage with diverse vegetation among mature trees

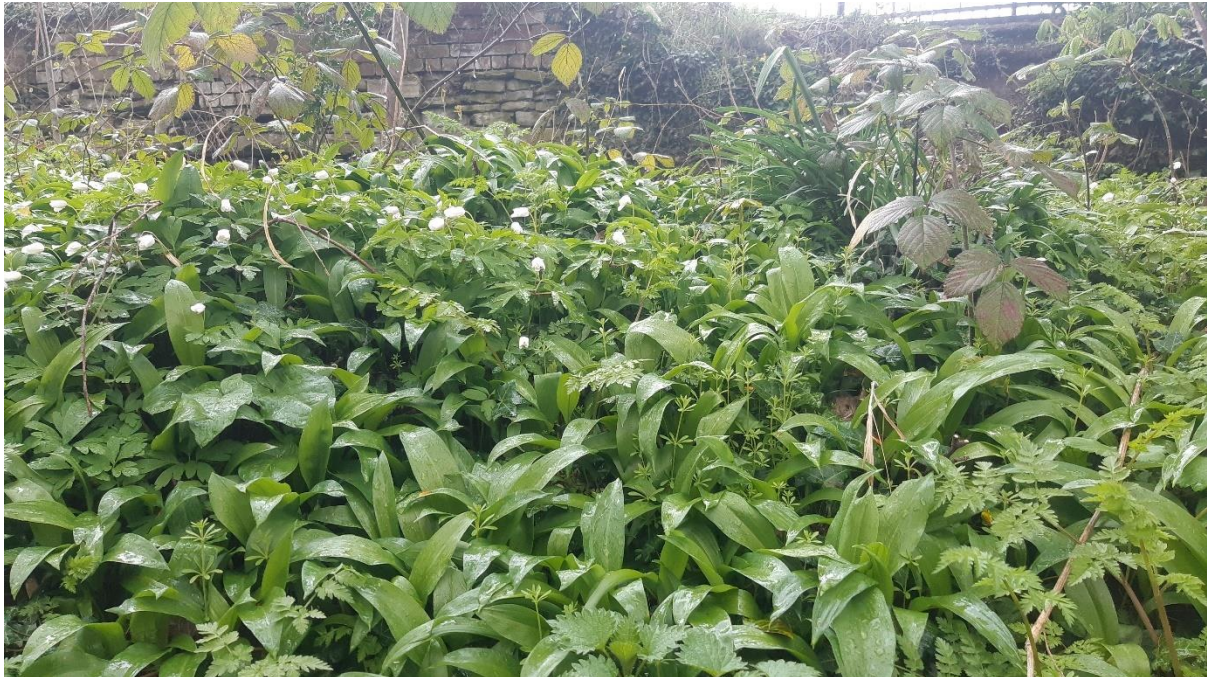
Figure 4: Year-round ground cover with a range of understory plants also reduces inputs of sandy substrate during winter storms – in contrast to seasonal die-back of invasive, annual plant species. Wood anemone (white flowers) indicates long-established woodland.

Floral species richness (e.g. Fig.4) is strongly linked to faunal diversity. Consequently, when non-native, invasive plant species out-compete stands of diverse native flora, the river suffers a reduction in subsidies from the terrestrial environment. At the time of the visit, invasive Japanese knotweed shoots were beginning to re-grow (e.g. Fig. 5).

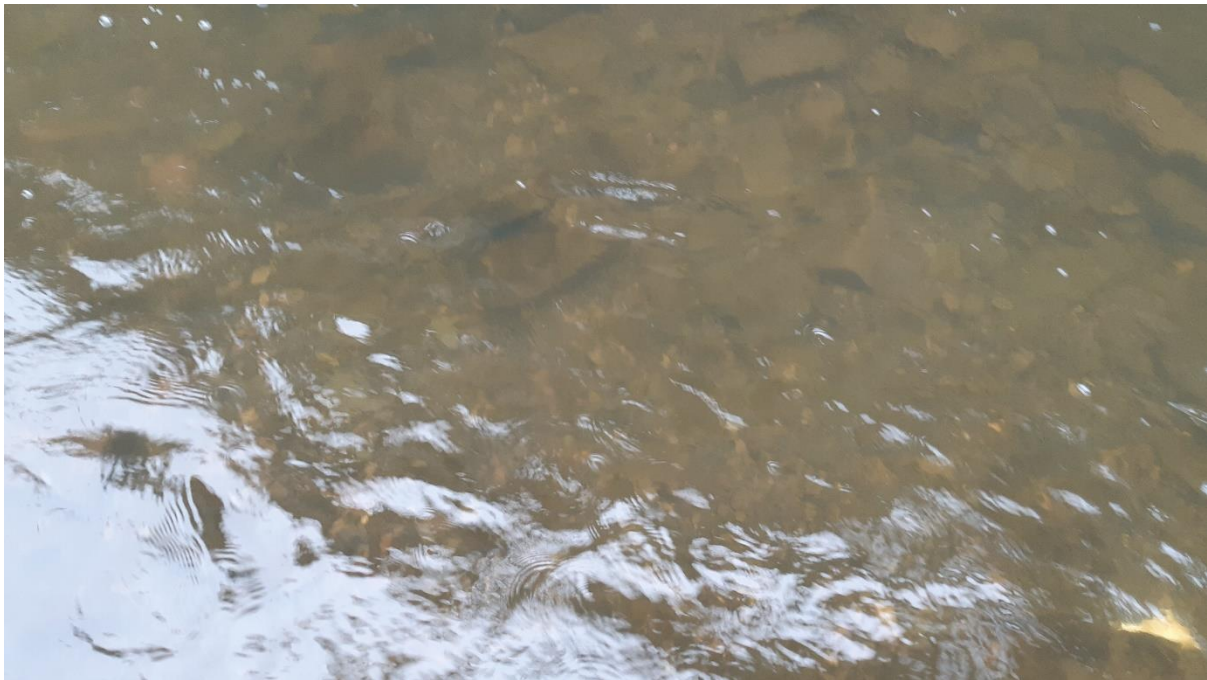
In the face of channel modifications, the relatively steep gradient has enabled some recovery of varied geomorphological features in the reach pictured in Figs. 1 and 2. Some cross-sectional variation in depth is evident where the channel bends and riffle, glide and pool habitat is represented. However, while cobble and small boulder-sized substrate is common, there was a *notable lack of gravel-sized particles* in this reach (e.g Fig.6).

Figure 6: Mainly cobble substrate, with a very thin scattering of gravel-size particles. For successful spawning, gravel deposits should ideally have a depth of at least 30 cm.

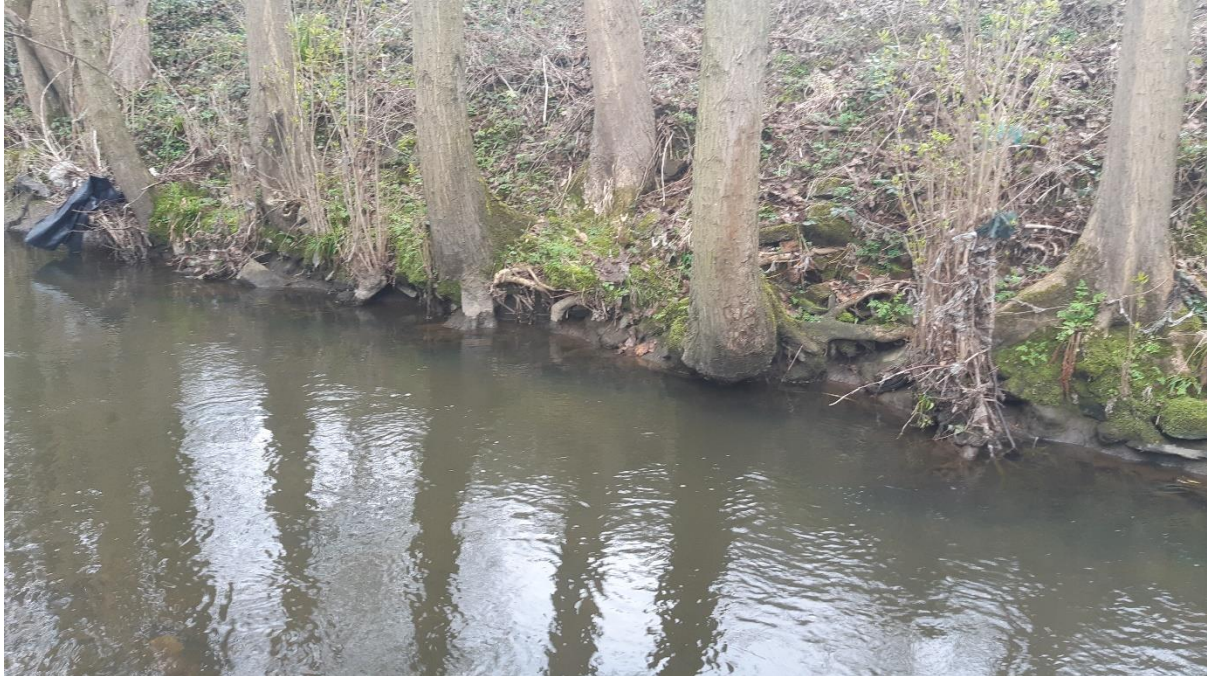
Where groups of mature riparian trees were present, these tended to be quite uniform age and size (e.g. Fig.7). This is probably a result of periodic blanket felling as a management strategy in response to perceived flood or structural risk. A better approach would be to undertake very light-touch rotational coppicing. Coppicing a scattered selection of $\leq 10\%$ of trees every two to three years – and promoting regrowth from stumps – would add structural variety in both the physical cover and light/shade regime. It is important to select the appropriate individual trees – at the appropriate percentage of total canopy – to ensure sufficient light for coppice regrowth.

Figure 7: Serried ranks of uniformly-aged mature trees can limit structural diversity in habitat and light/shade regime.

Low, bushy regrowth of coppiced stumps close to the waterline can provide valuable refuge habitat and maintain local cooling – while also allowing light to reach adjacent understory species. Coppicing is much preferred to pollarding. Bushy regrowth from coppiced stumps occurs at a height that is much more beneficial to aquatic species.

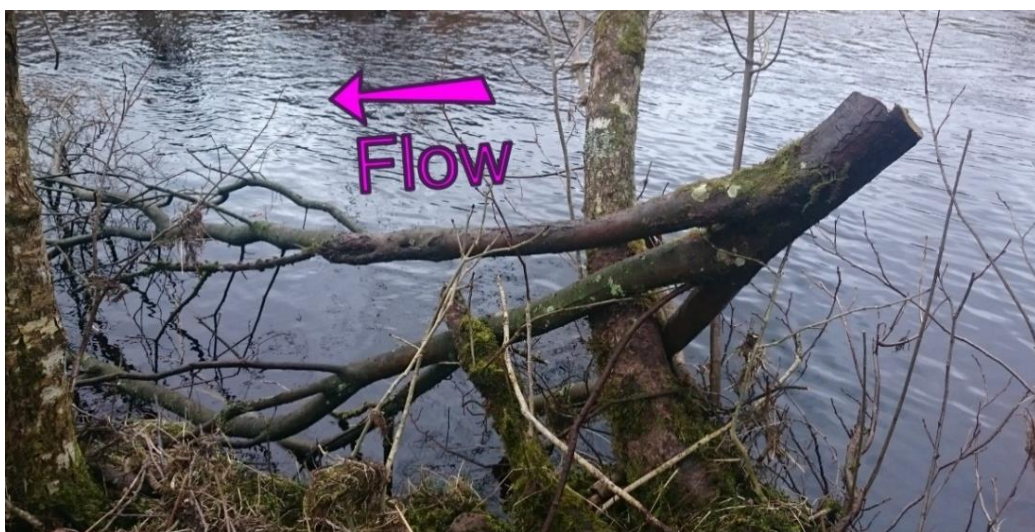
Figure 8: Lodging a union (joint between major stems) around the **upstream** side of a stable anchor point mimics nature and creates fantastic habitat (particularly important to overwinter survival of a range of aquatic species).

From an ecological perspective, the extremely stable tree “hanger” structures exemplified in Fig.8 are a vital means of maximising the conversion of hatched eggs to juvenile fish that survive beyond their first winter. In systems such as the Sheaf, where spawning habitat is scarce, complex, submerged brash has a huge potential to increase resilience of self-sustaining wild trout populations.

Having mature trees with well-established root systems at the waterline also provides an ideal opportunity to increase complex, submerged cover. Appropriately-sized crown material arising from coppicing can be lodged around these stable anchor points in a manner that closely mimics stable, naturally-arising large woody material (e.g. Fig.8).

The compounding beneficial effects of stable woody material (both large and coarse) give it a very high ecological value. Using lodged tree crown material to create tree “hanger” installations is a secure method to achieve ecological and flood-risk gains.

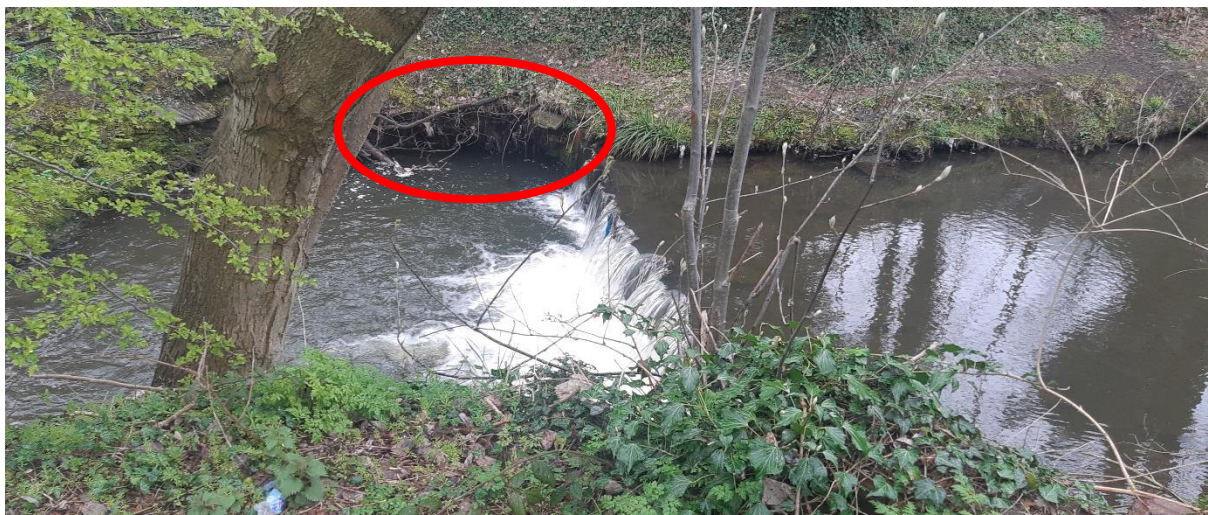
A sheet piling weir (Fig.9) was noted at 53.357500, -1.481389. While the intended function is not known, its negative ecological impacts are obvious.

Figure 9: Sheet piling weir impounding a significant upstream reach and eroding the foot of the steep RB (ringed in red). This pattern of erosion is typical when barriers are installed perpendicular to the bank. While this could naturally bypass the weir, the bank supports a path and associated infrastructure. The weir is a barrier to up and downstream migration as well as a trap for substrate on its upstream side. Interventions could deliver ecological and local infrastructure benefits.

Impounding (holding back) water on the upstream side of a weir reduces the structural complexity of habitat. Fewer distinct micro habitats are supported in uniform habitat and this reduces biodiversity. As mentioned already, the essential transport of riverbed substrate is interrupted by weirs, starving the downstream reach of raw materials to create diverse habitat. The importance of downstream migration of fish and other mobile aquatic organisms is often under-appreciated compared to upstream migration. A wide range of species need to move between different habitat features to complete full lifecycles. Such movements are often not confined to a single direction of travel. Fitting a fish pass or fish-passage easement to a weir has many limitations. Such structures can be passable to one species – while representing a near complete barrier to others. Downstream migration is rarely improved and habitat typically remains degraded by impoundment and substrate-trapping effects. While fish passes can be an essential “least-worst” last resort, they should never be the first option considered.

In this case it is likely to be worth comparing the outcomes of complete removal (best ecological option) versus notching out the central third of the weir down to the downstream bed-level (close second - to be used if there is a risk to infrastructure). Hydraulic modelling and structural engineering assessments are recommended. This is the best way to understand the response of the channel to each alternative intervention – and to assess the associated structural consequences. The financial costs of such assessments may well be lower than the average cost of technical fish pass construction and installation.

- In consultation with appropriate geomorphology and structural engineering expertise, remove (preferably) or notch (where removal is not achievable) all sheet pile weirs identified in this survey.
- Commission detailed feasibility studies for the two stonework weirs identified in this survey with a view to:

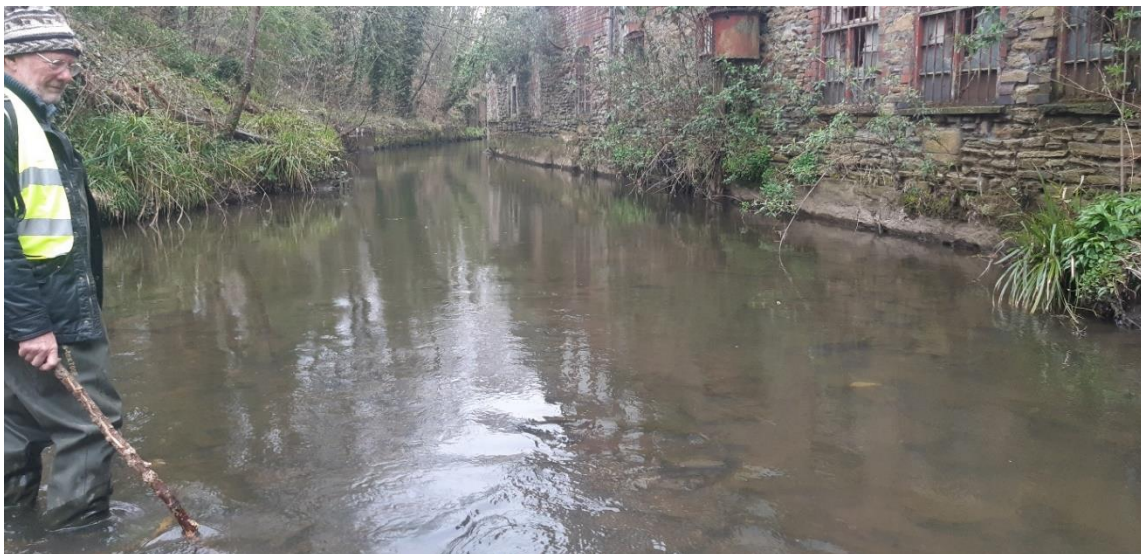
Reduced impoundment is also likely to provide additional opportunities for riparian vegetation to re-establish in areas where marginal habitat has been drowned out by a weir (e.g. Fig.10 showing the impounded reach upstream of the weir featured in Fig.9).

Figure 10: The wetted perimeter of the impounded reach includes the stone walls of riverside buildings on the LB (right of frame) and prevents natural riverbank formation.

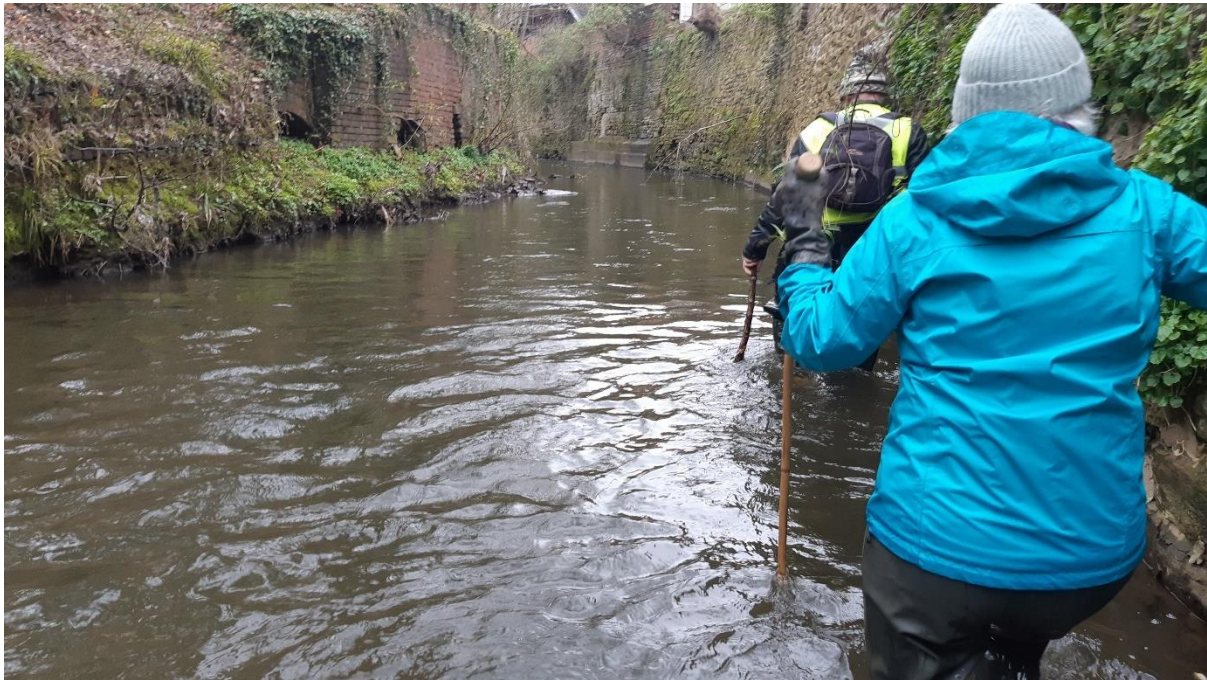
That unnatural, box-shaped channel is typical of the majority of the reach surveyed for this report (e.g. Figs. 11 and 12)

Figure 11: Walled, incised channel cut off from its floodplain with limited opportunity for riparian woodland growth. Locking the channel in place with stonework also prevents the natural migration of a river across its floodplain over time. This lack of temporal variation is highly significant and generally under-appreciated when compared to structural complexity. Washout of gravels is also likely within the confined, vertical-walled "chute".

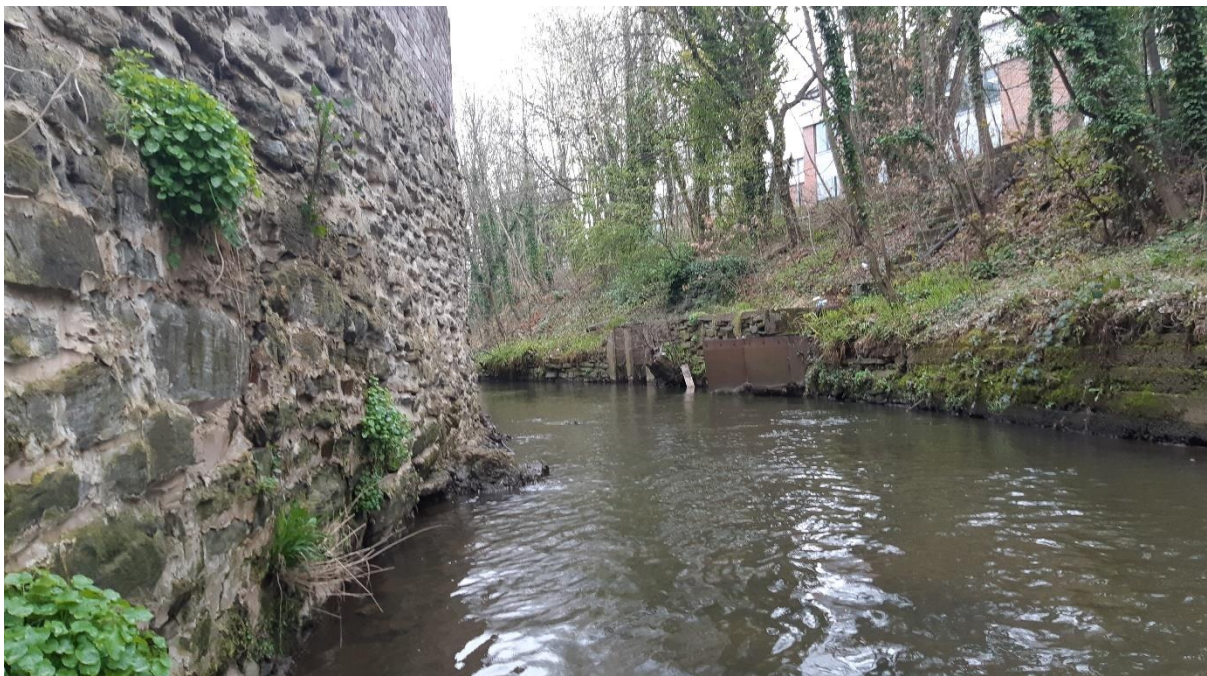
Figure 12: Walled channel with box-shaped wetted cross-section. The ecological value of patches of mature woodland is magnified by the extent of engineered modifications to the river.

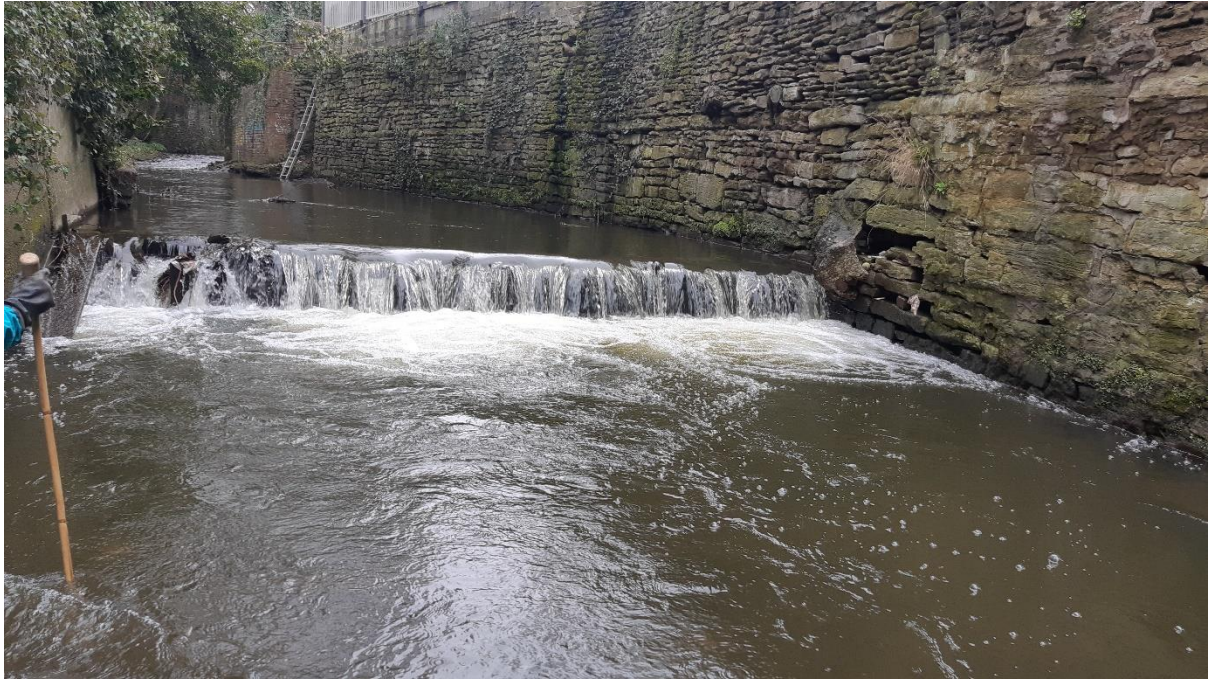
Figure 13: Sheet piling weir at 53.356944, -1.483056. Proposals to notch or remove the weir need to investigate whether walls within the impounded reach rely on hydrostatic pressure from the river for stability. Again, the existing erosive forces amplified by a barrier placed perpendicular to the walls should be incorporated into decision-making.

Another sheet-piling weir was encountered at 53.356944, -1.483056 (Fig. 13). The same recommendations for investigating the feasibility of either complete removal or notching of the central third of the weir are proposed.

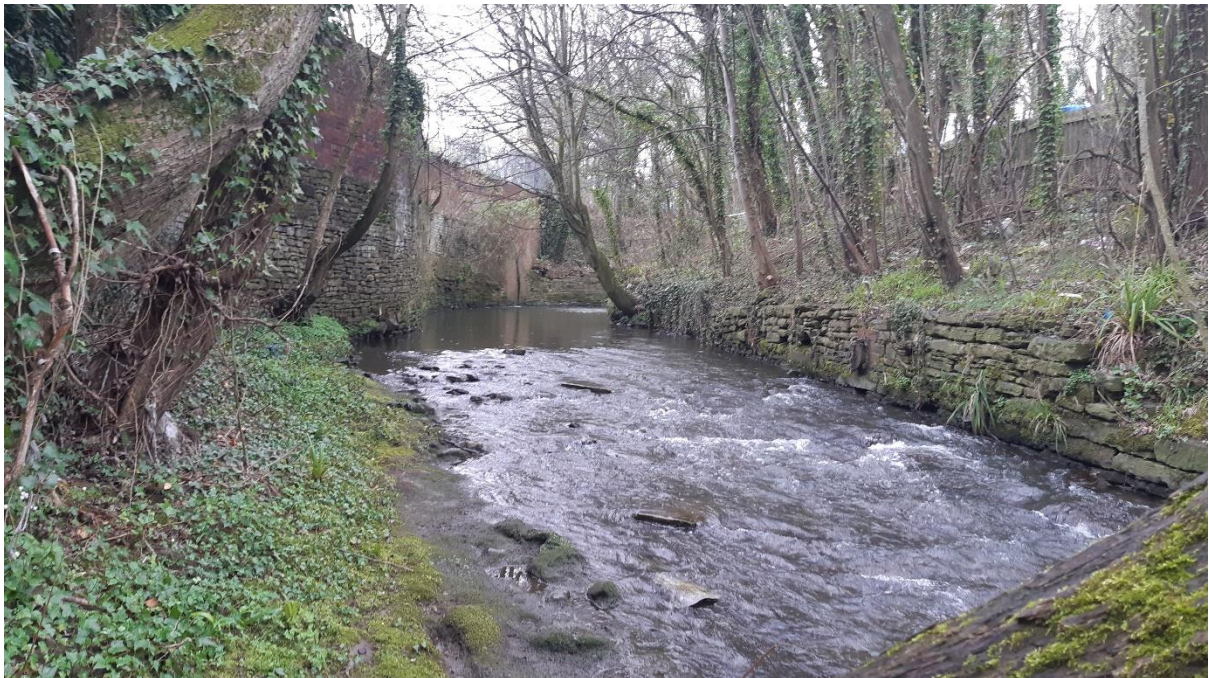
The longitudinal bed slope of the River Sheaf enables it to create riffle and pool sequences, despite the many engineered constraints (e.g. Fig. 14).

Figure 14: Pool, riffle and boulder-rapids sequence providing habitat variety in the face of multiple constraints. Every instance where even a short section of channel has its retaining walls set back from the channel results in the formation of a more natural, vegetated riverbank (left of frame, foreground).

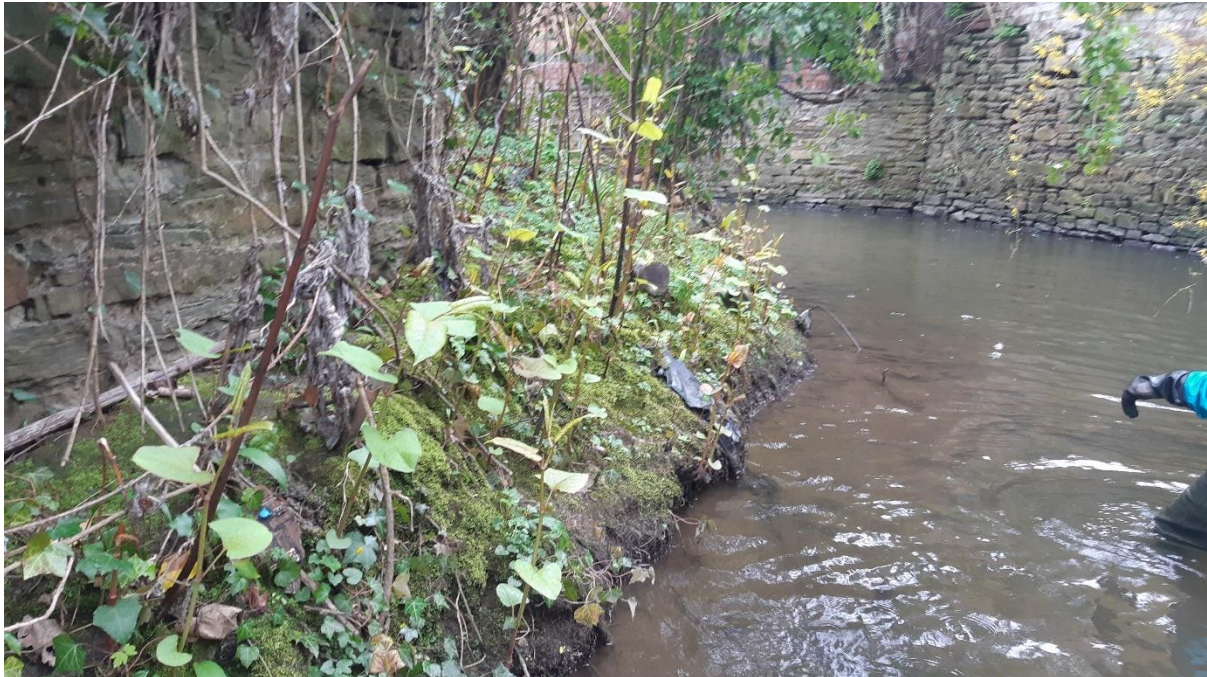
More extensive stands of Japanese knotweed were observed in the vicinity of 53.356111, -1.483889 (e.g. Figs. 15 and 16). These should be targets for control efforts as, while substantial, they still occupy a relatively limited

Figure 15: A more significant stand of Japanese knotweed putting the footings of this wall at risk as well as shading-out native riparian plant species.

- Control Japanese knotweed via a programme of stem injection by appropriately qualified personnel.
 - This could be contracted to local specialists such as the River Stewardship Company.

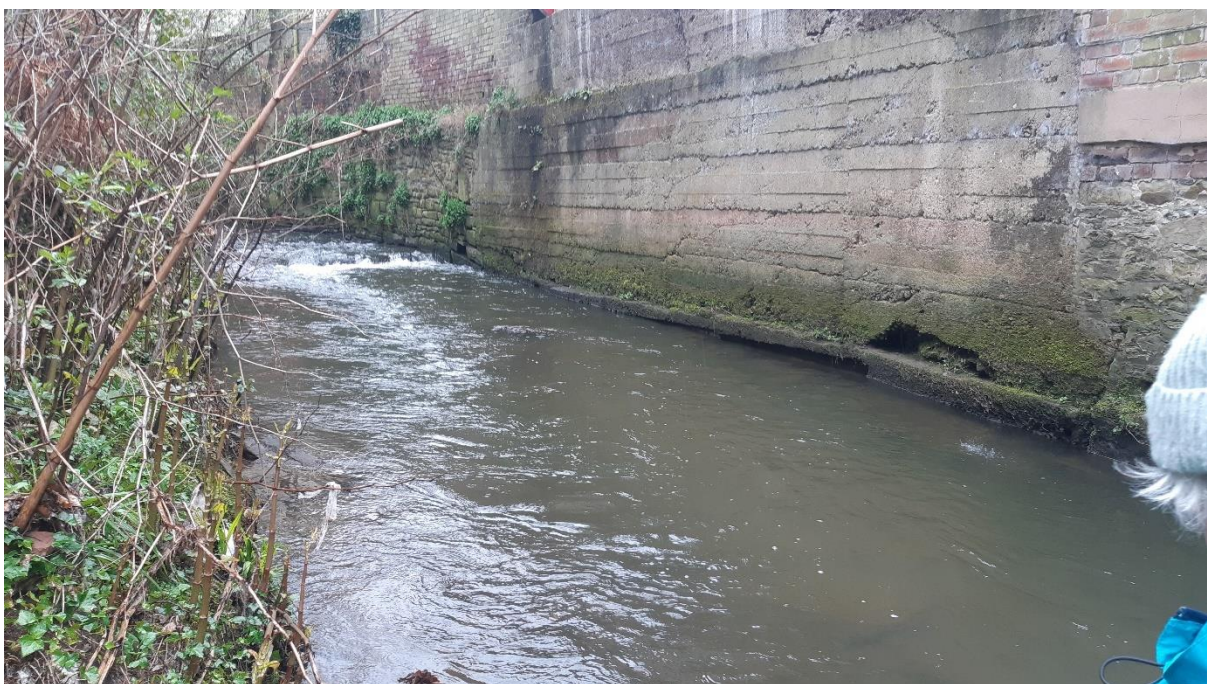
Figure 16: Japanese knotweed on the RB and gradual erosion of stonework on the LB.

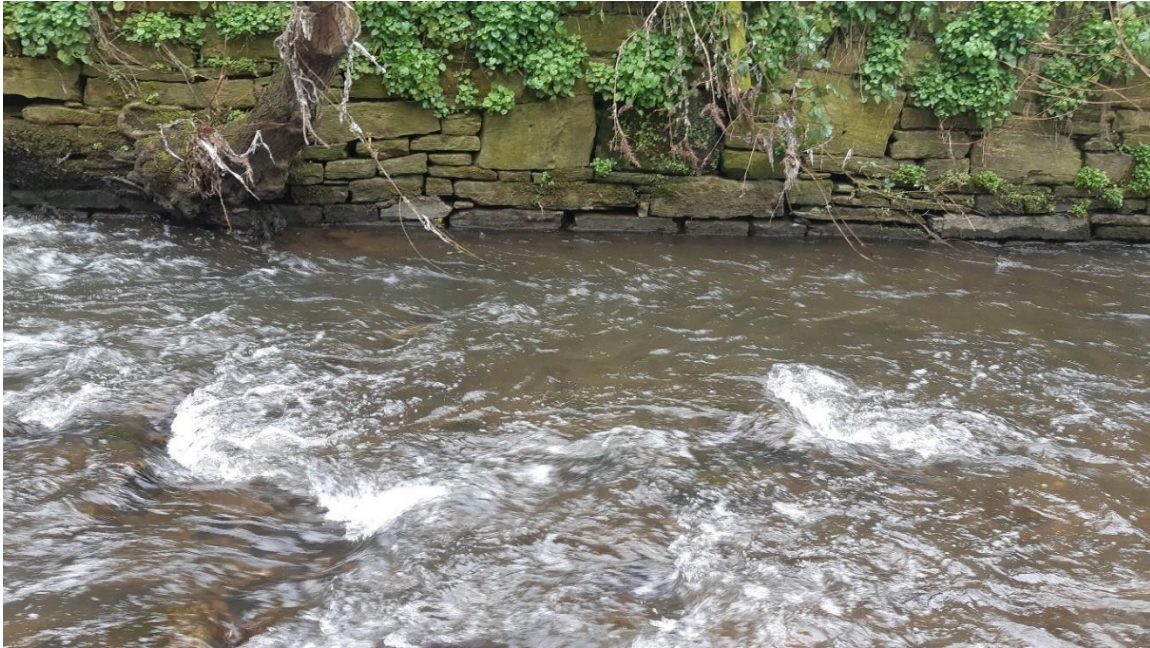
Along with surface water drainage from surrounding urban development, Combined Sewer Outfall (CSO) discharges were also evident (Fig.17). Rag waste trapped in trailing vegetation is a typical symptom of untreated sewage discharges. Outfalls with significant volumetric capacity were noted at 53.355833, -1.483889 (Fig. 18).

Figure 17: The type of complex flows known as "pocket water" to fly fishers in the foreground – with the remains of rag-waste from untreated sewage discharges trailing from strands of vegetation in the background.

- Undertake volunteer-led water quality monitoring measures such as:
 - Visual inspection programme (and request discharge data) for known outfalls to identify and report problems.

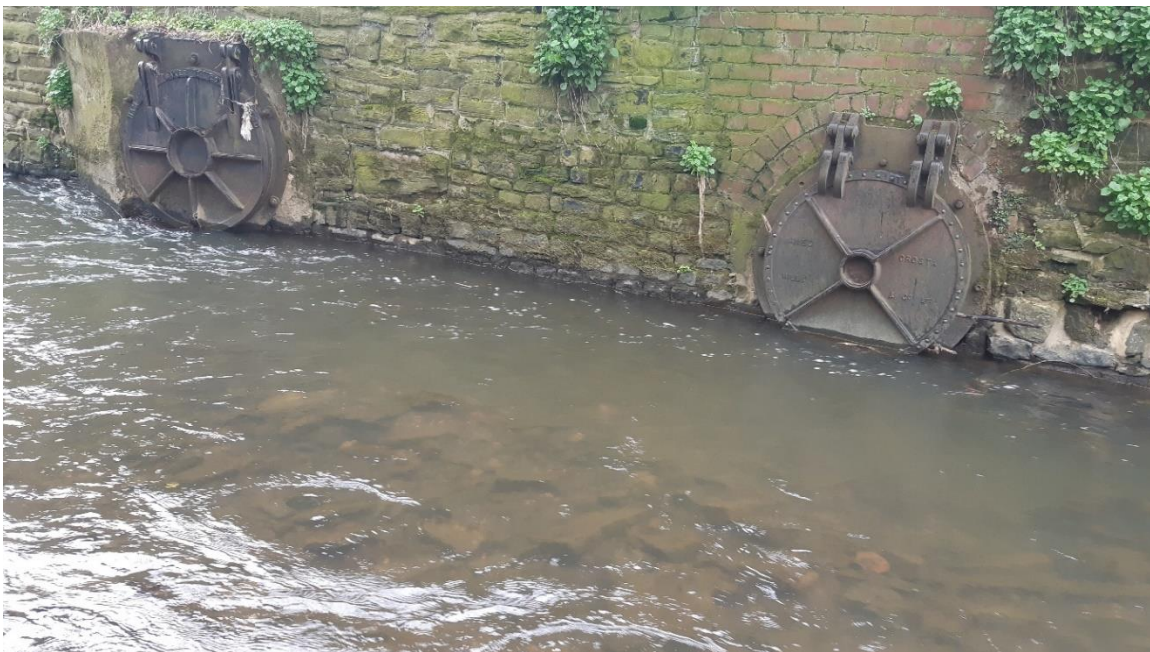
Figure 18: Paired outfalls at 53.355833, -1.483889. Discharges can be within consented values while still having a negative ecological impact. However, when it comes to discharges outside of consented values, the vigilance of members of the Sheaf and Porter Rivers Trust could be highly significant. At a basic level, ensuring discharges are consistent with extreme rainfall rather than unregulated discharges during dry weather helps to identify potential problems.

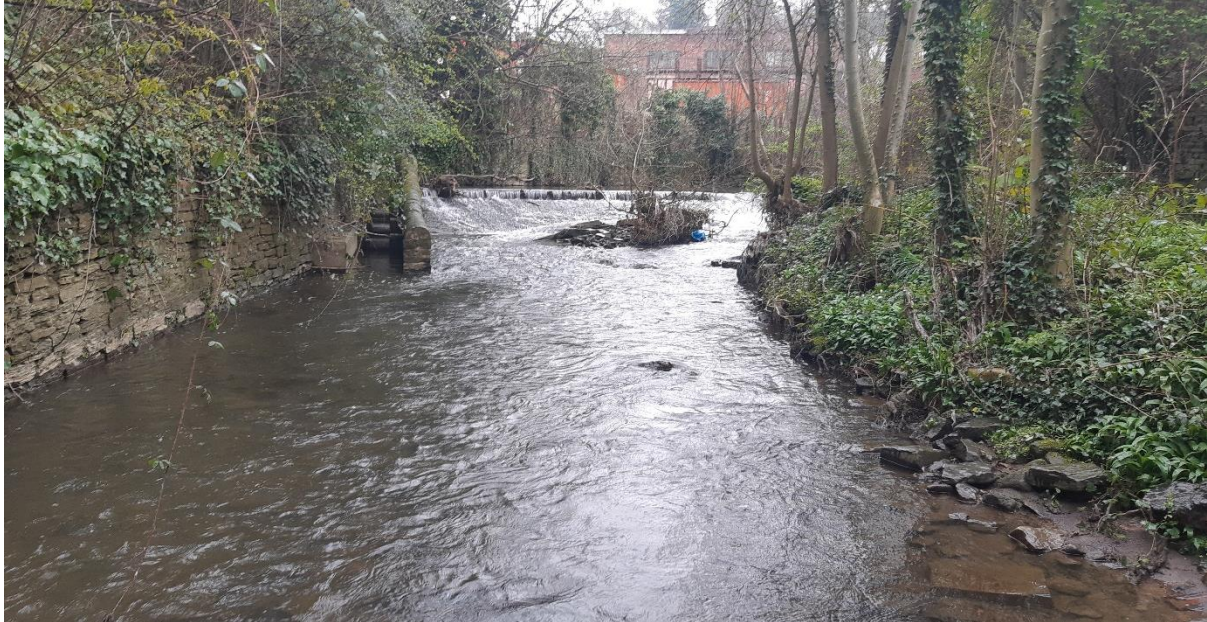
A stone weir with a narrow, unfortunately blocked, fish pass was photographed at 53.355556, -1.483611 (Fig. 19). Blockage is another common disadvantage of fish passes compared to weir removal. A substantial deposit of riverbed material has been colonised – and consequently stabilised – by vegetation on the LB downstream of the weir. The combined influence of a wider channel below the weir and the focused

scour arising during spate conditions below the weir have created a patch of valuable habitat. However, the ecological value of this feature exists at the cost of habitat degradation in the impounded reach upstream of the weir. Careful assessment of structural implications of notching or removal (via both geomorphological modelling and structural assessment) would be necessary – along with establishment of heritage value.

Figure 19: Stone weir with blocked fish pass on the RB and vegetated cobble bar feature on the LB.

- Establishing feasibility and cost of removal (including accommodation of heritage value).
 - Where removal is infeasible, seeking innovative designs for rock-ramp style solutions.

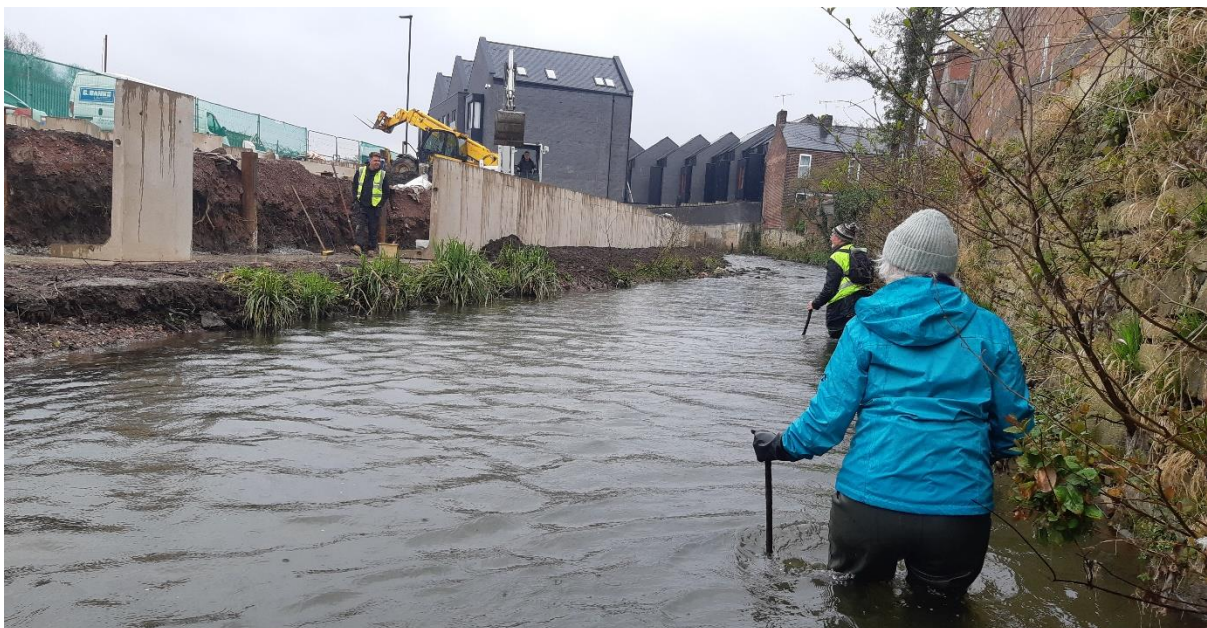
The impounding influence of the weir extends throughout the reach adjacent to the ongoing riverside property development (Fig. 20; photographed from 53.355278, -1.483611)

Figure 20: Riverside development on the RB adjacent to impounded reach created by the weir shown in Figure 19.

The developer has committed to planting locally appropriate riparian vegetation as a condition of their planning. Protecting such vegetation from extreme high and/or low flows while it establishes will be essential to its survival.

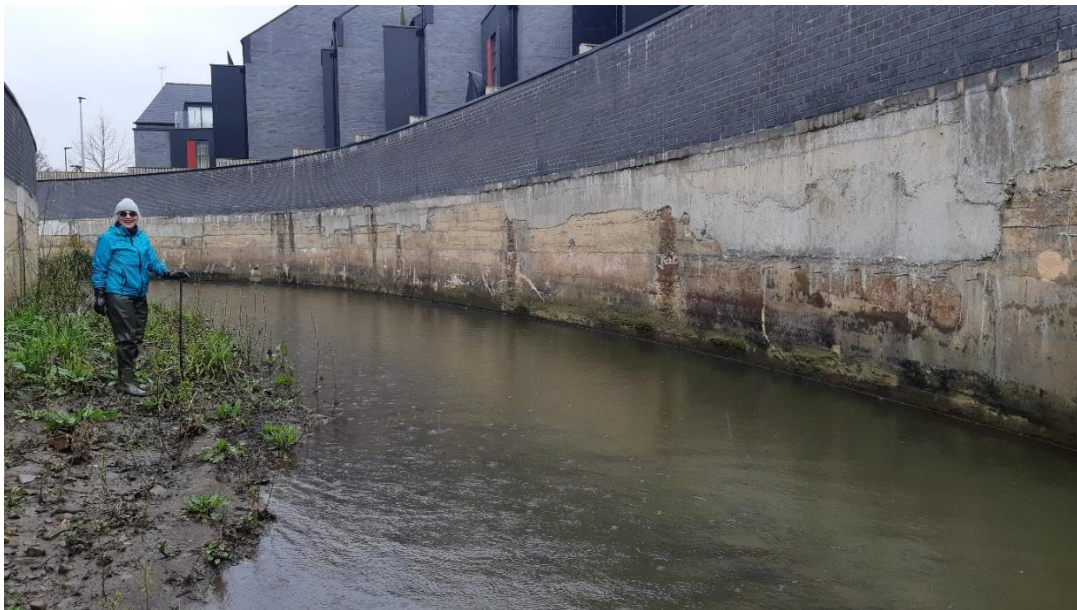
Vertical walls at 53.354722, -1.483889 on the LB were previously associated with a large laundry site (Fig. 21). The habitat within this reach is particularly uniform with very little of the complex cover required to balance and sustain predator/prey dynamics. Establishing ivy in tubs and encouraging it to climb down/along the walls would create some cover and improve the river corridor/natural aesthetic

Figure 21: Uniform habitat with very little complex cover.

- Invertebrate monitoring at sample sites above and below known outfalls.
- Seek to establish ivy along the smooth concrete walls at the site of the previous laundry (and consider the same for any concrete walls installed as part of riverside property developments).

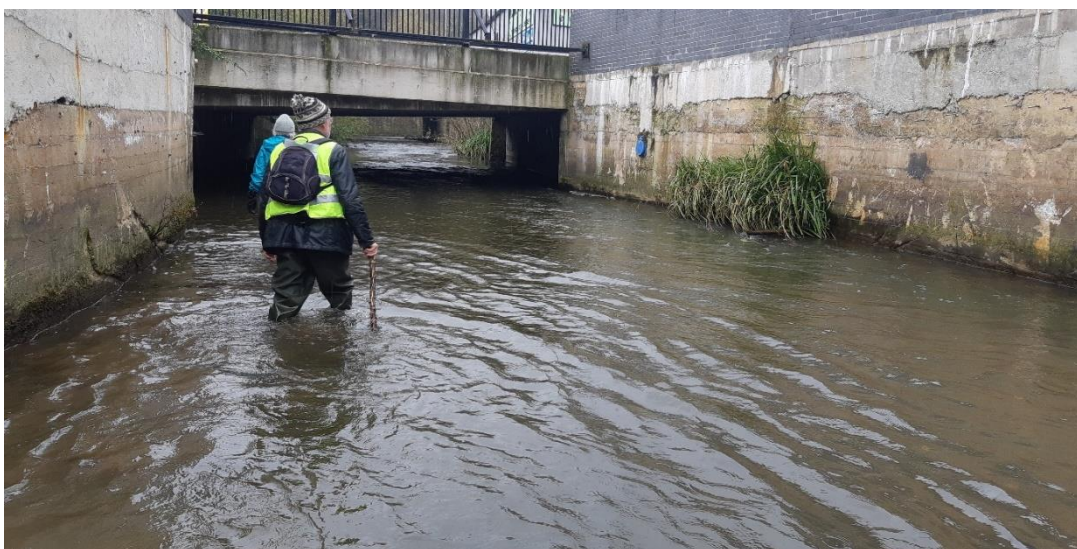
With that in mind, a remarkable example of cover vegetation arising despite such unfavourable conditions is shown in Fig.22.

Figure 22: A clump of what appears to be pendulous sedge established in narrow cracks in the concrete (right of frame).

- Explore opportunities to establish pendulous sedge and/or field wood rush along the toe of concrete walls to create trailing/partially-submerged cover.

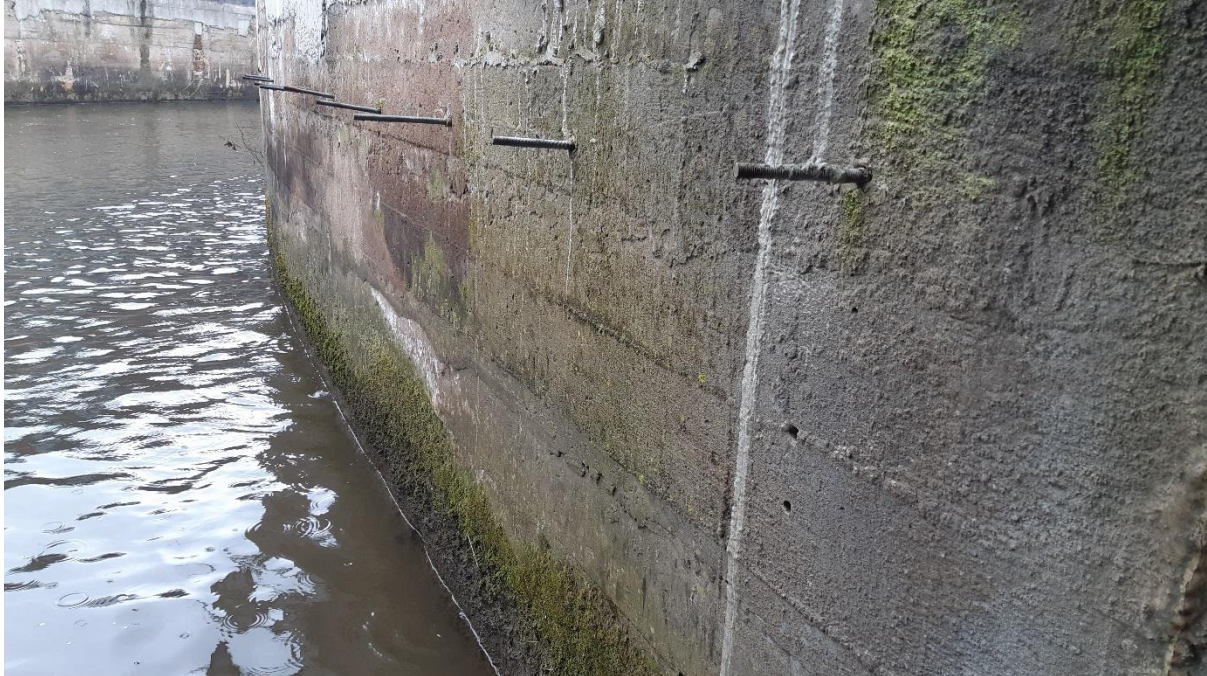
The presence of protruding, threaded bar wall ties throughout the concrete-walled section (e.g. Fig. 23) could provide potential anchor points for installations designed to promote similar plant colonisation. This would require some innovative design and installation in order to be successfully delivered. Similarly, it would aid coverage by climbing plants such as ivy.

Figure 23: Protruding threaded bar ties were common throughout the concrete-walled section as far upstream as 53.354387, -1.483811.

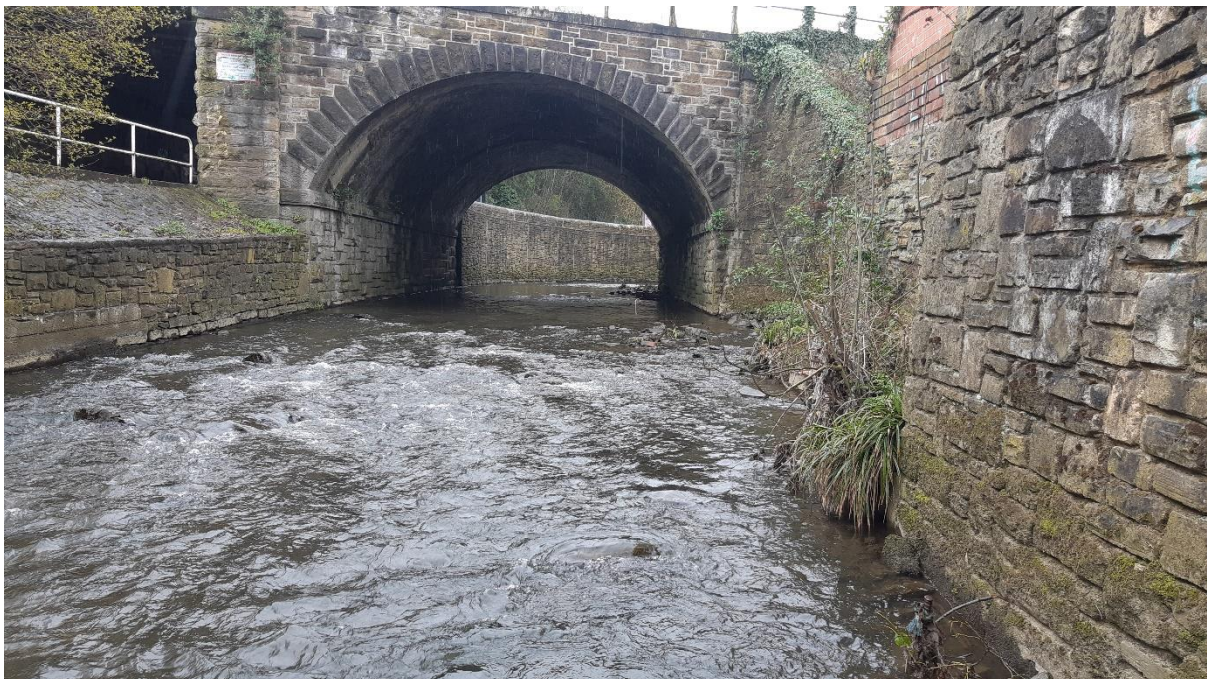
Progressing upstream, further above impounding structures, there is sufficient longitudinal bed slope to support riffle and glide sequence formation (e.g. Fig. 24).

Figure 24: Boulder riffle below a bend pool and glide. Some vegetation colonisation of the rougher block stonework was evident here.

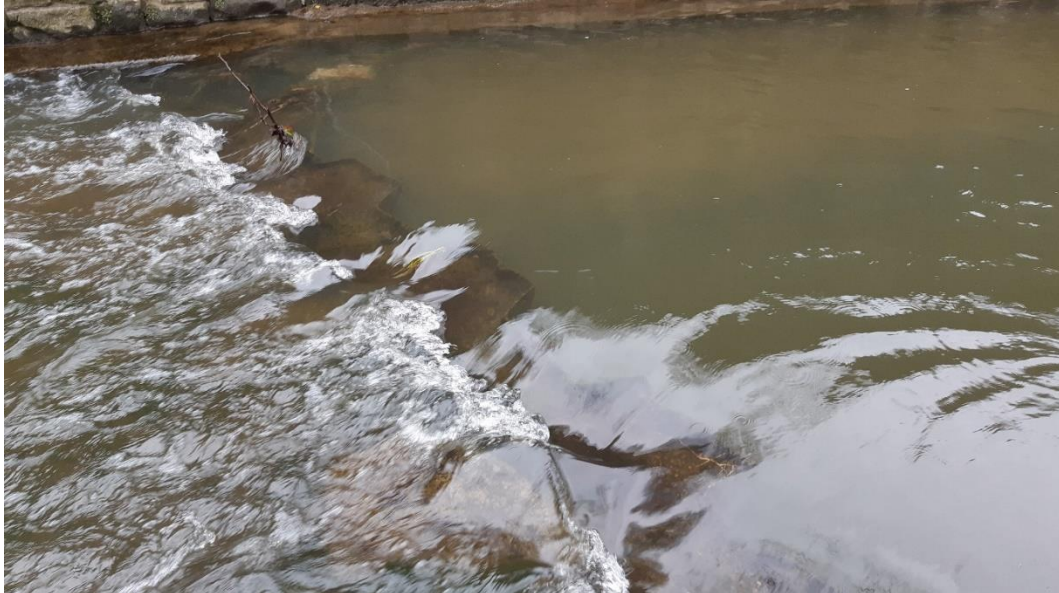
Just upstream of the bridge shown in Fig. 24, another sheet pile weir was found at 53.353558, -1.483511. With recent rainfall, this specific structure was drowned out by the flow level within the Sheaf at the time of the visit. It is important to note that this is still a significant barrier to both fish migration and substrate transport.

Figure 25: Sheet pile weir at 53.353558, -1.483511. Notching down to bed level of the central third (as a minimum) or complete removal should be investigated.

In common with the other sheet pile weirs documented in this report, complete removal or notching of the central third of this structure should be pursued. The notch could, potentially, be created by knocking the middle piles further in (following services search). Structural and geomorphological investigations are needed to inform the feasibility of alterations to weirs in these settings.
