Advisory Visit River Sheaf (Leyburn Rd to Climbing Works)

Paul Gaskell (pgaskell@wildtrout.org)

05/04/2023

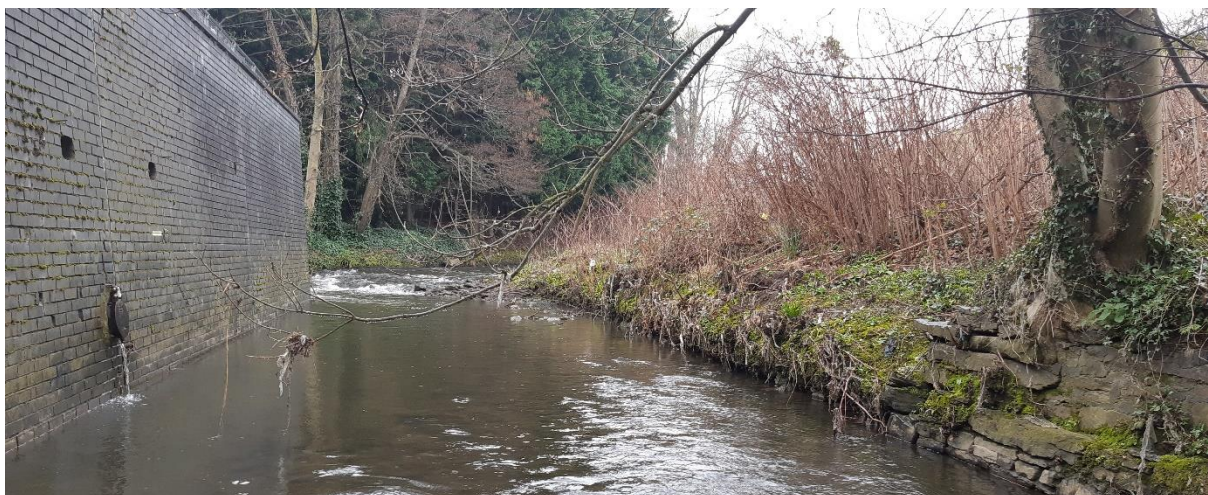
The largest stand of Japanese knotweed encountered during the survey was noted at 53.353333, -1.483889 (Fig. 26). This is adjacent to the railway line and should be a priority for control efforts.

Figure 26: Dead canes of Japanese knotweed on the LB (right of frame).

- Control Japanese knotweed via a programme of stem injection by appropriately qualified personnel.
 - This could be contracted to local specialists such as the River Stewardship Company.

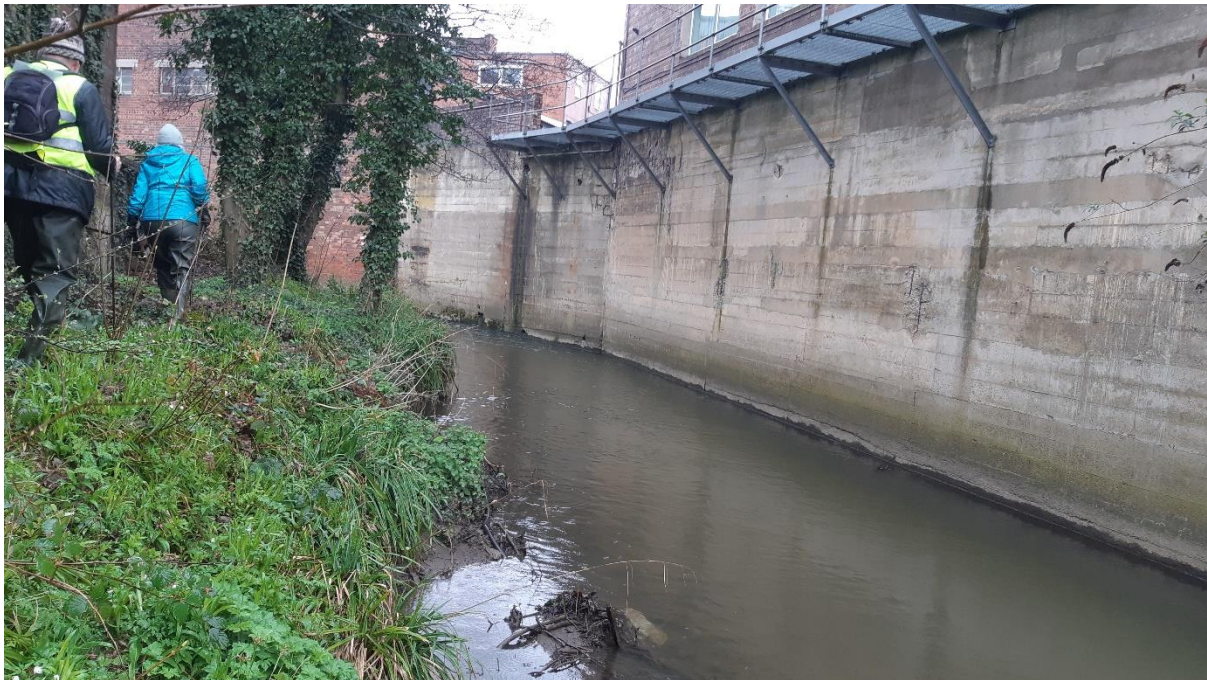
Towards the upstream limit of the reach surveyed for this report, the LB is a vertical wall, with some woodland and understory vegetation established on the RB (e.g. Fig. 27). Efforts to monitor and control invasive plant species will provide ecological benefits here as elsewhere in the surveyed reach.

Figure 27: Narrow strip of ecologically valuable riparian vegetation on the RB.

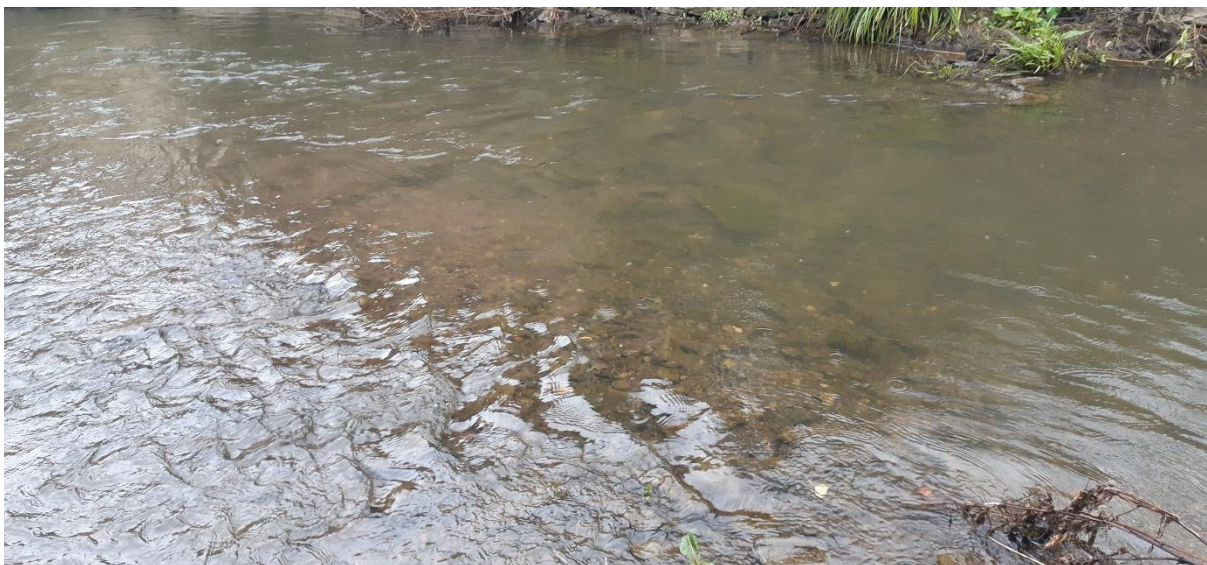
Probably the largest deposit of gravel with potential value as spawning habitat (Fig. 28) was noted downstream of the large weir which defined the upstream limit of this survey (Fig. 29).

Figure 28: Gravel deposits that appear to have the most potential as spawning substrate out of the examples noted during this survey.

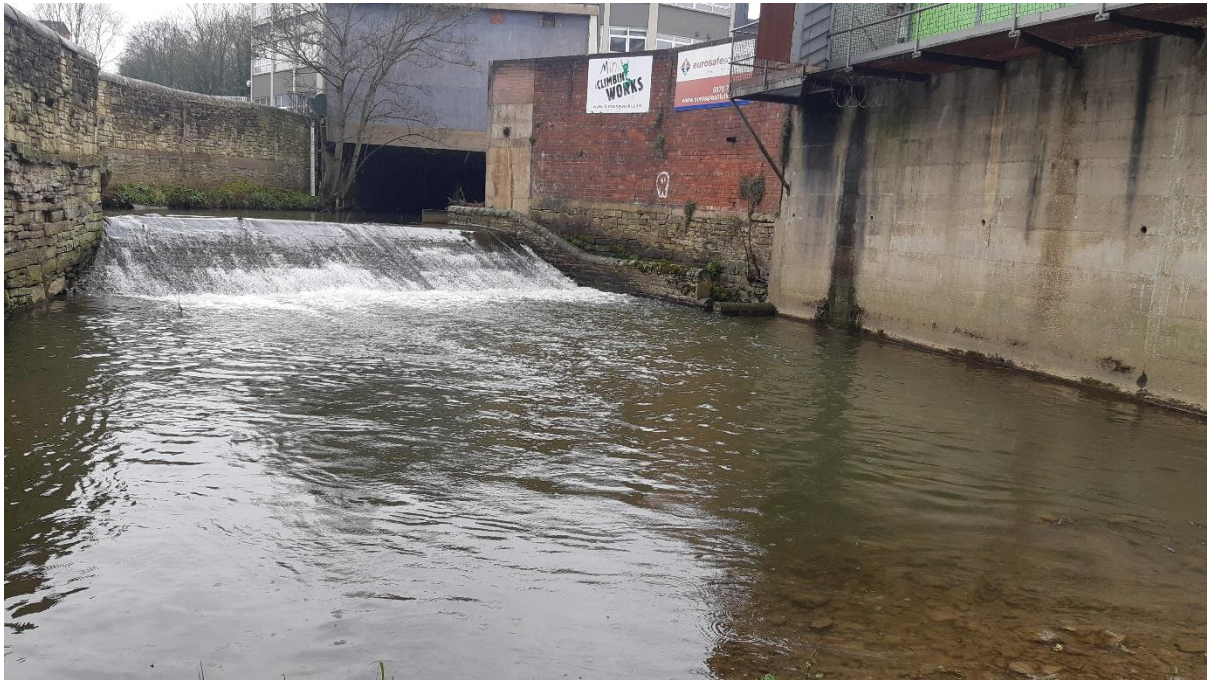
Figure 29: Weir defining the upstream limit of this survey at 53.351603, -1.484237

Assessing the feasibility of weir removal here is recommended – with the understanding that there is a high likelihood of significant engineering costs. The stabilisation of infrastructure upstream of the current weir's position appears to be a challenging proposition. Depending on the outcome

of removal feasibility assessments, a range of improved fish passage options may be appropriate to consider. In particular, whether there is sufficient space downstream of the weir to successfully construct a rock ramp of a low enough gradient to allow fish passage. While any designs need to be tailored to the size of the site, a large scale example is shown in Fig.31.

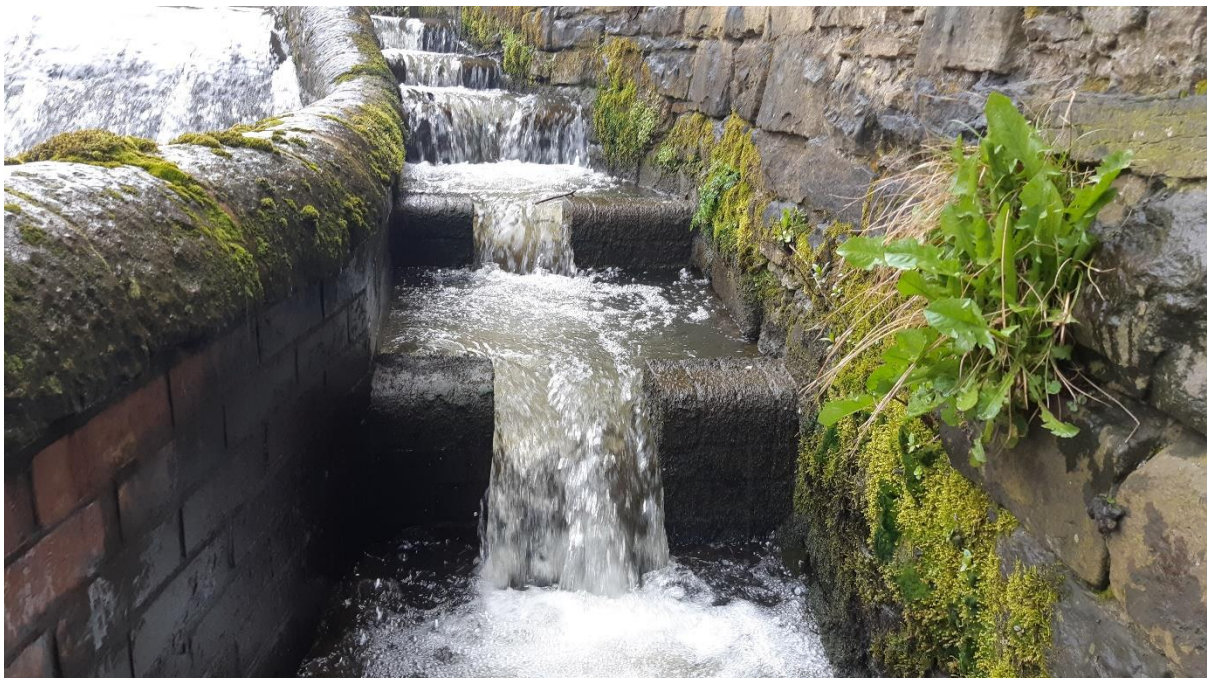
The fish pass fitted to the LB of the weir was not blocked by debris (and possibly receives some maintenance efforts); though does contain some sizeable vertical jumps between each chamber (Fig. 30). The location and design of the downstream entrance to the fish pass provides very poor attraction flow relative to the attraction flow from the weir itself (Fig. 29).

Figure 30: While much more passable than the weir, finding and negotiating this fish pass will be a significant challenge for all species of fish.

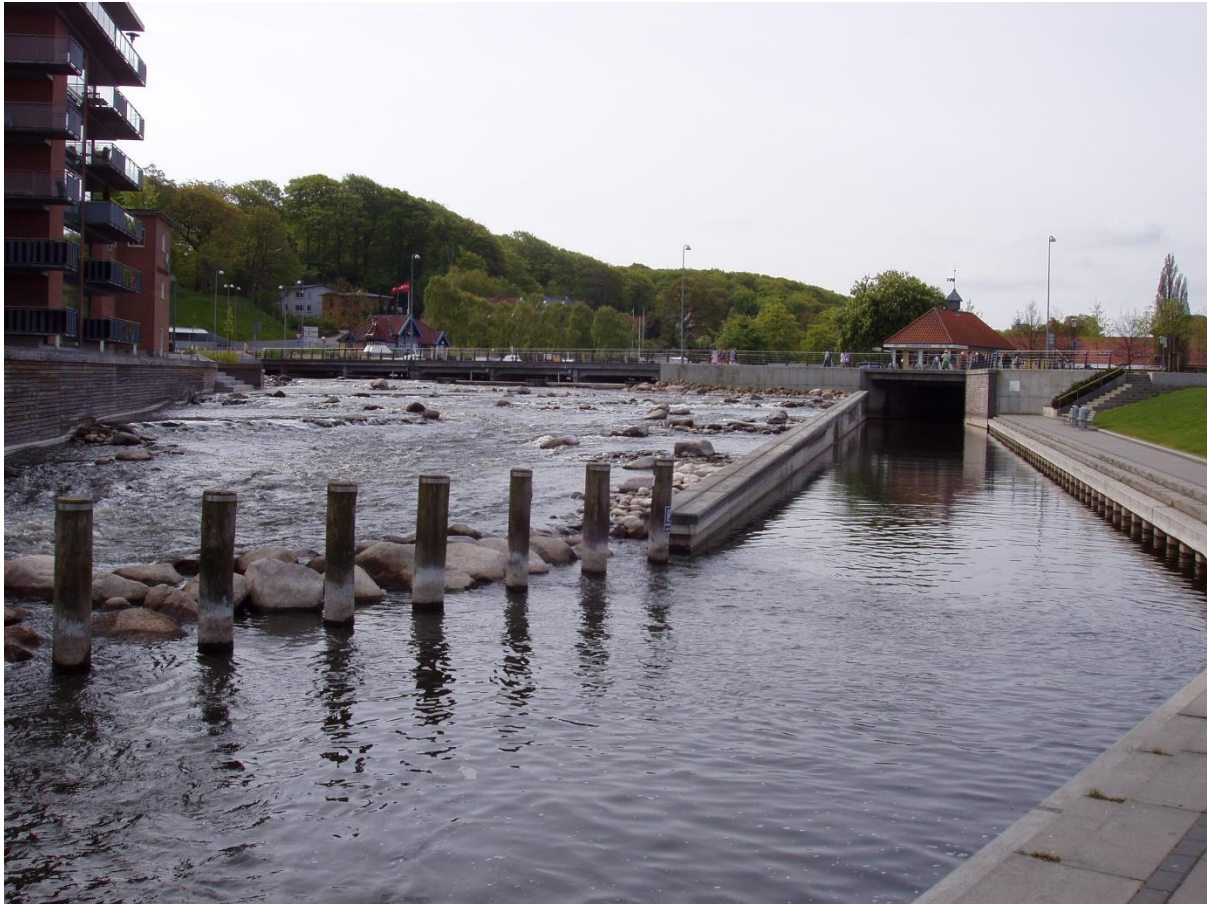
Figure 31: Rock ramp overcoming a large weir. Note that the use of stone substrate has created a nature-like riverbed which has inherent habitat value.

As well as actually creating habitat with ecological value, rock ramp designs may not necessarily need to occupy the full width of the channel. The example shown in Fig.31 has a constructed retaining wall that confines the rock ramp to the left of the frame. This allows the lower water level along the LB (right of frame) which, in turn, allows the riverside path and navigation lock to exist below the raised water level created within the rock ramp. This type of solution could be used to mitigate concerns over flood risk.
